AWB210 (AMOSAWB210SM20140309)

Water Bath

Service Manual

AWB 210 Water Bath

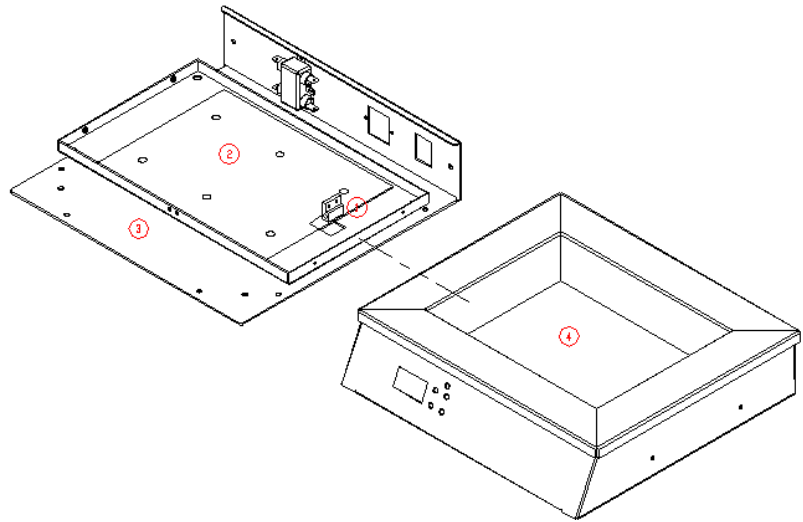
3: Exploded View

- ① Sensor
- ② Heater
- ③ Base- plate
- ④ Water though

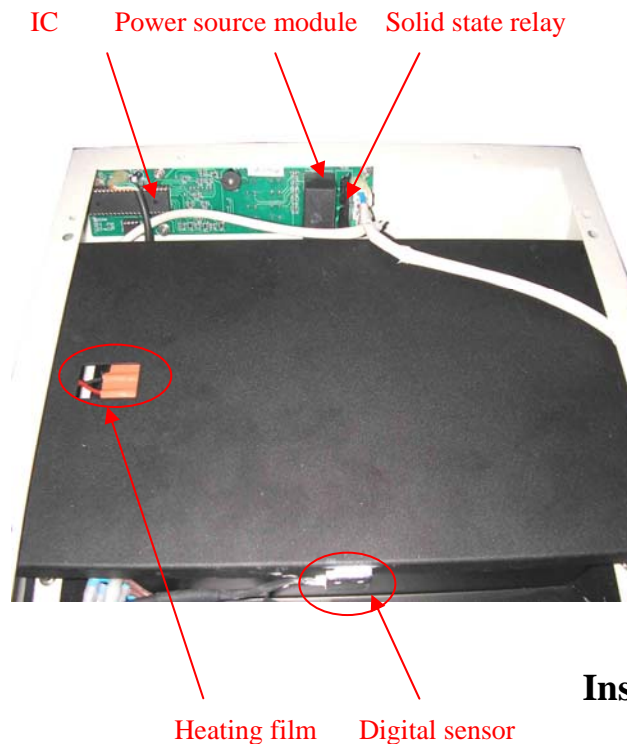
Inside Schematic diagram

Maintenance: Loosens the six screw in the base-plate with philip screwdriver, and take down the base-plate, and there will be a power source module on the main board in the instrument as it shows on the picture. And

take down the power source module from the main board by hand, if it is difficult to take down the power source module with hand, you can use the flat apparatus as slotted screwdriver to take down the power source module by inserting the flat apparatus in the slot and tipping it up slightly, and then take it down and replace a new power source module.

Maintenance : Loosens the screw with the screwdriver, and you will see the digital sensor as it showed in the picture, and then Loosens the screw in the sensor to replace the sensor.

Maintenance: Loosens the screw with the screwdriver, and you will see the IC as it showed in the picture. you can use the flat apparatus as slotted screwdriver to take down the IC by inserting the flat apparatus in the slot and tipping it up slightly and then take it down to replace a new one.

Maintenance : Loosen the six screws in the base-board with the philip screwdriver, take down the base-board and you will see the heating film as it showed in the picture. And then loosen the four screws on it to replace the heating film.

Maintenance: Loosen the six screws in the base-board with the philip screwdriver, take down the base-board and you will see the solid state relay as it showed in the picture. Take down the damaged SSR to replace a new one.
